OAK RIDGE
Y-12
PLANT

BUILDING 9712 RAVINE DISPOSAL SITE

APRIL 3, 1984

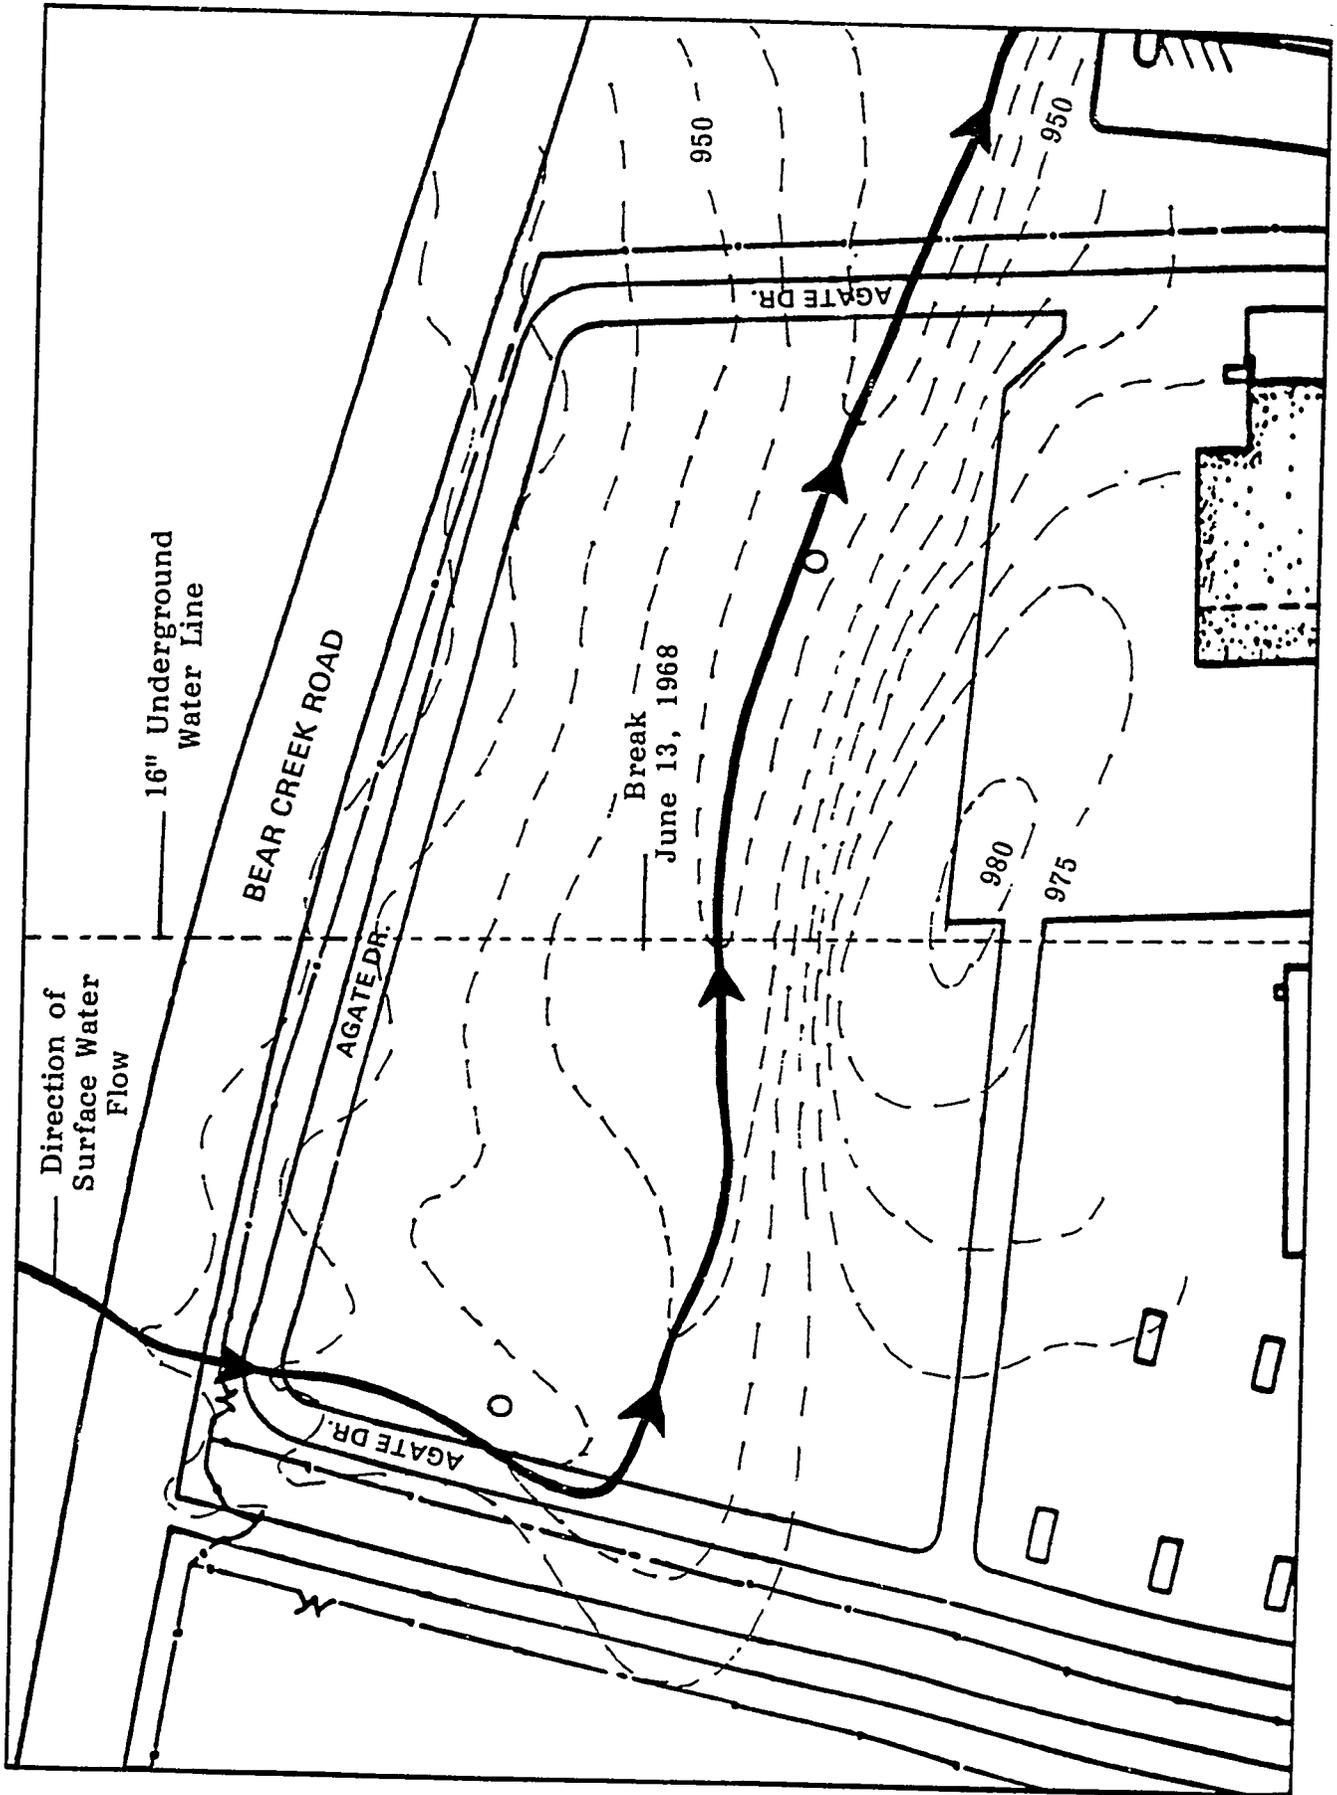
Figure 1. Composite Drawing of Ravine Area (Contour Lines are Dated 1943)

This appendix shows a composite drawing of the ravine area (Figure 1). The positions, as they are today, of the garage, Bear Creek Road, Agate Drive, and the water line break are from the Area Block Plan drawings. The contour lines are from a 1943 survey map and show the ravine (direction of surface water flow) and the crest of the hill to the south.
