Fig. 2.1.17. ORR and ORNL perimeter monitoring locations.

RECORD COPY
#117
010999

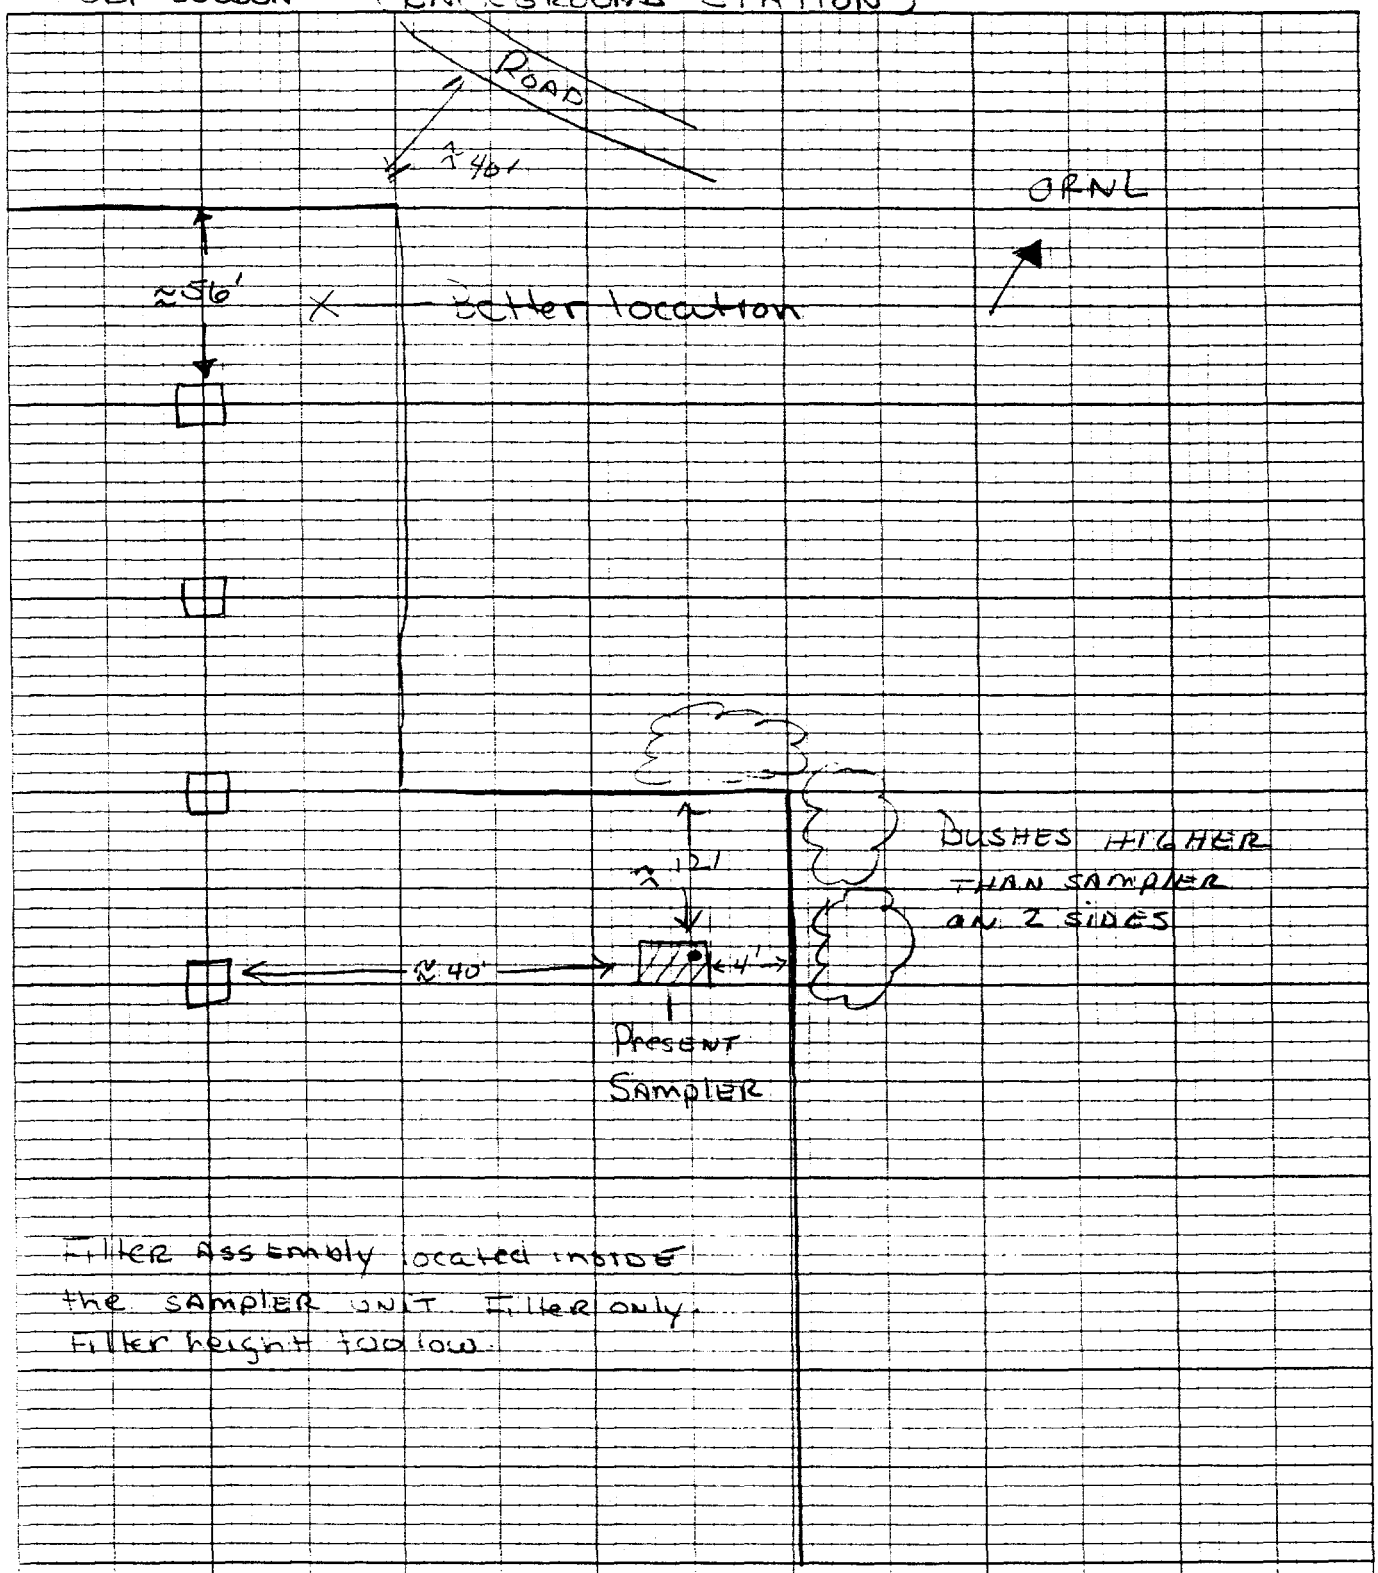
FORT LOUDON (BACKGROUND STATION)

Filter Assembly located inside the SAMPLER UNIT. Filter only. Filter height too low.

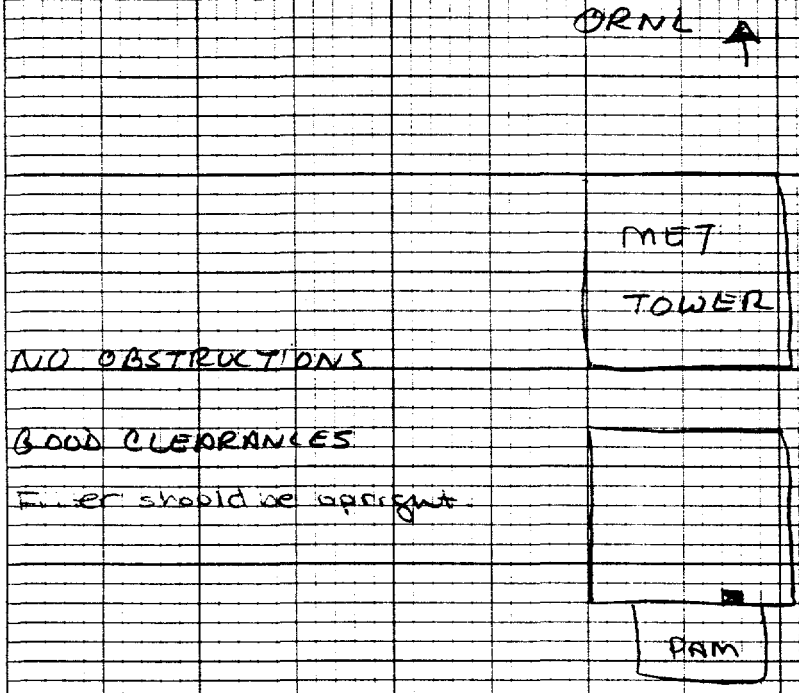
#3 X-10 MET TOWER

NO OBSTRUCTIONS

GOOD CLEARANCES

Filter should be upright.

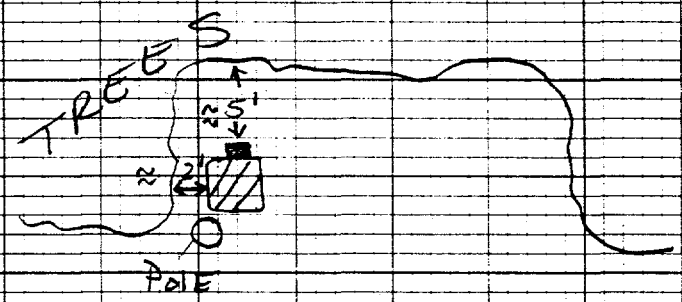
#9 ACROSS the ROAD FROM X-10

OLD STATION
VERY POOR CLEARANCE AND CONFIGURATION.
FILTER MOUNTED TOO CLOSE TO THE GROUND

FILTER SHOULD BE ON OPPOSITE SIDE OF SAMPLER, HIGHER OFF THE GROUND AND IN AN UPRIGHT POSITION.
TREES SHOULD BE CLEARED TO THE LEFT OF THE SAMPLER AT LEAST FOR 10 METERS

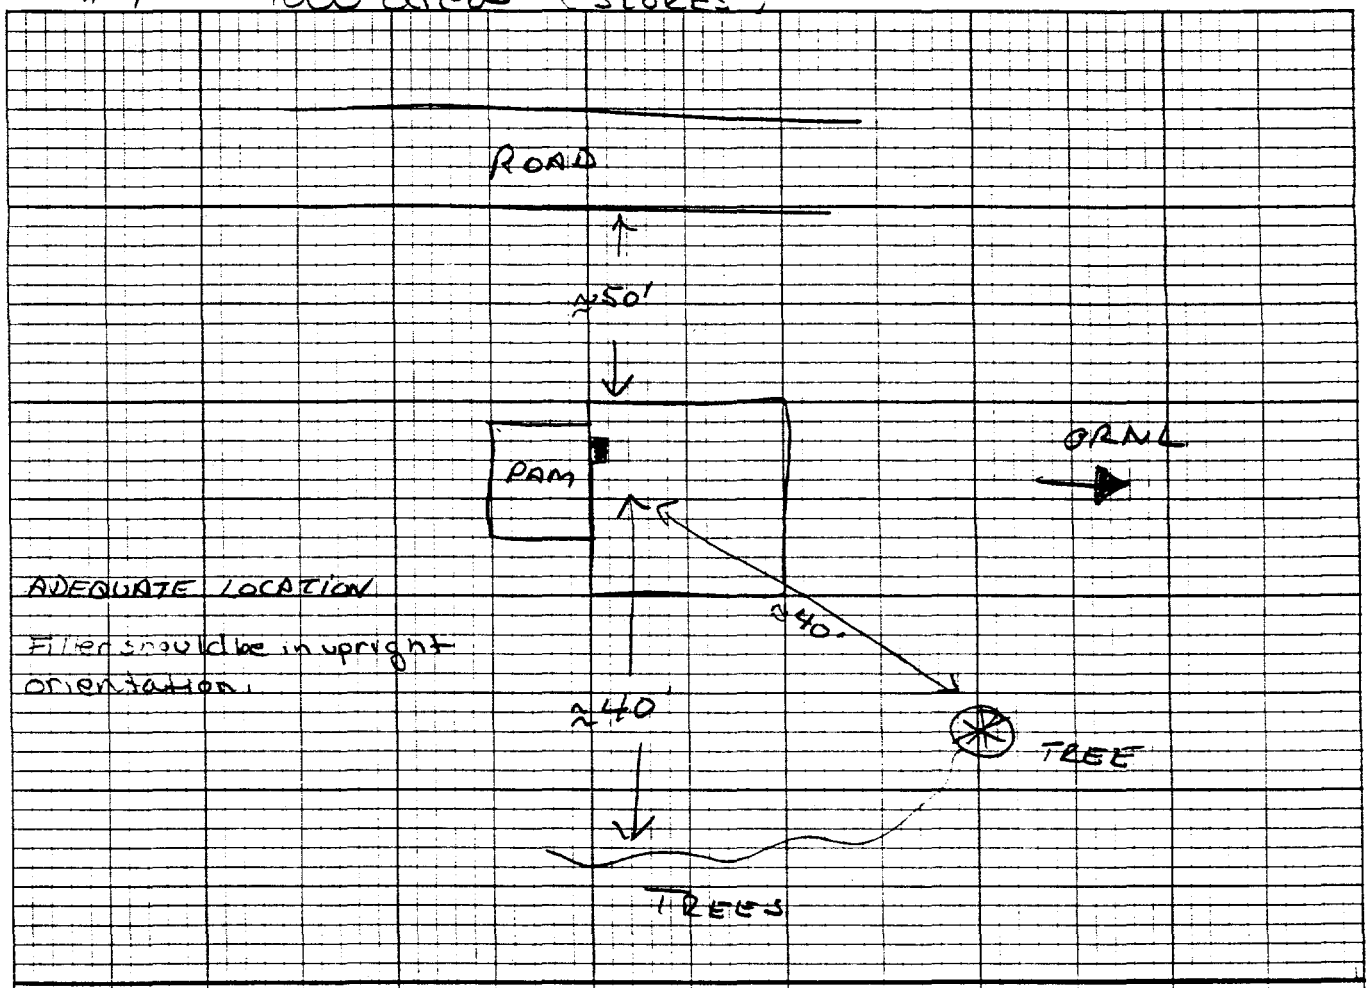
#7 7000 area (STORES)

ADEQUATE LOCATION

Filter should be in upright orientation.

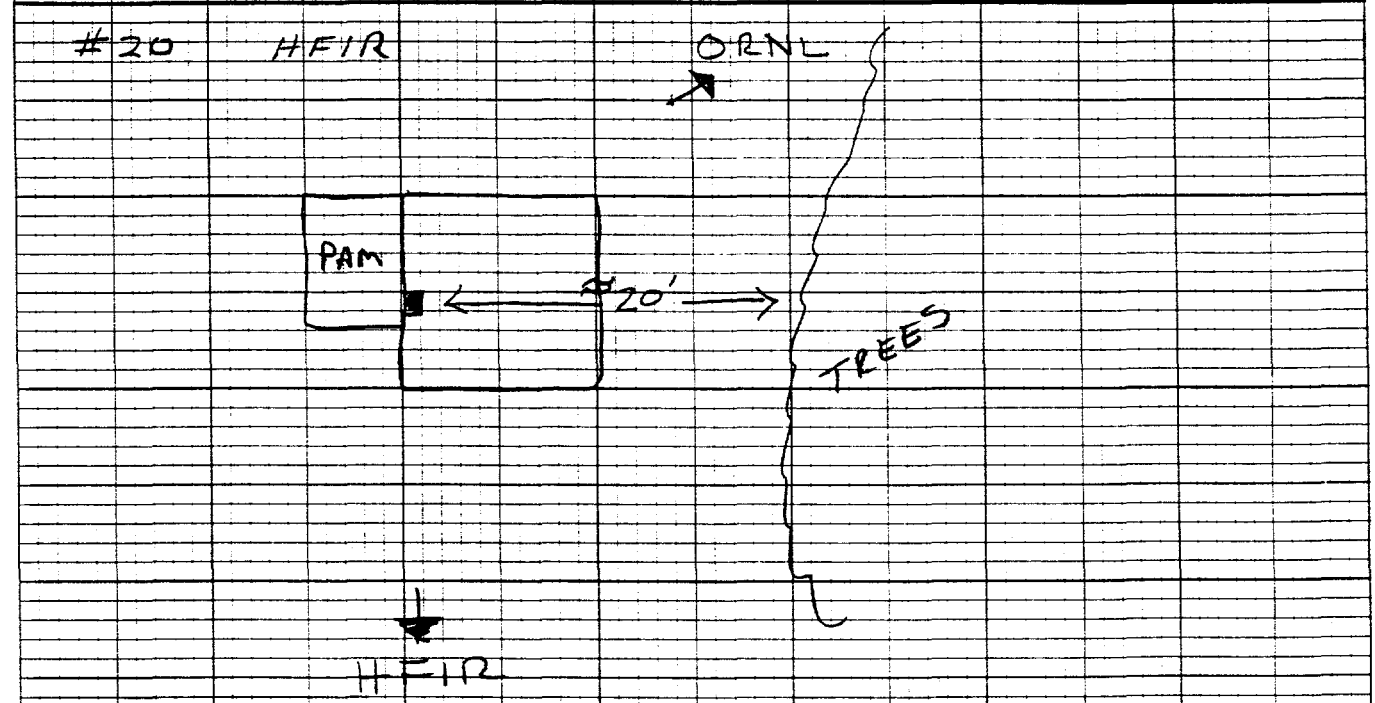
#20 HFIR

ADEQUATE

TREE LINE SHOULD BE CUT BACK.

Filter should be upright

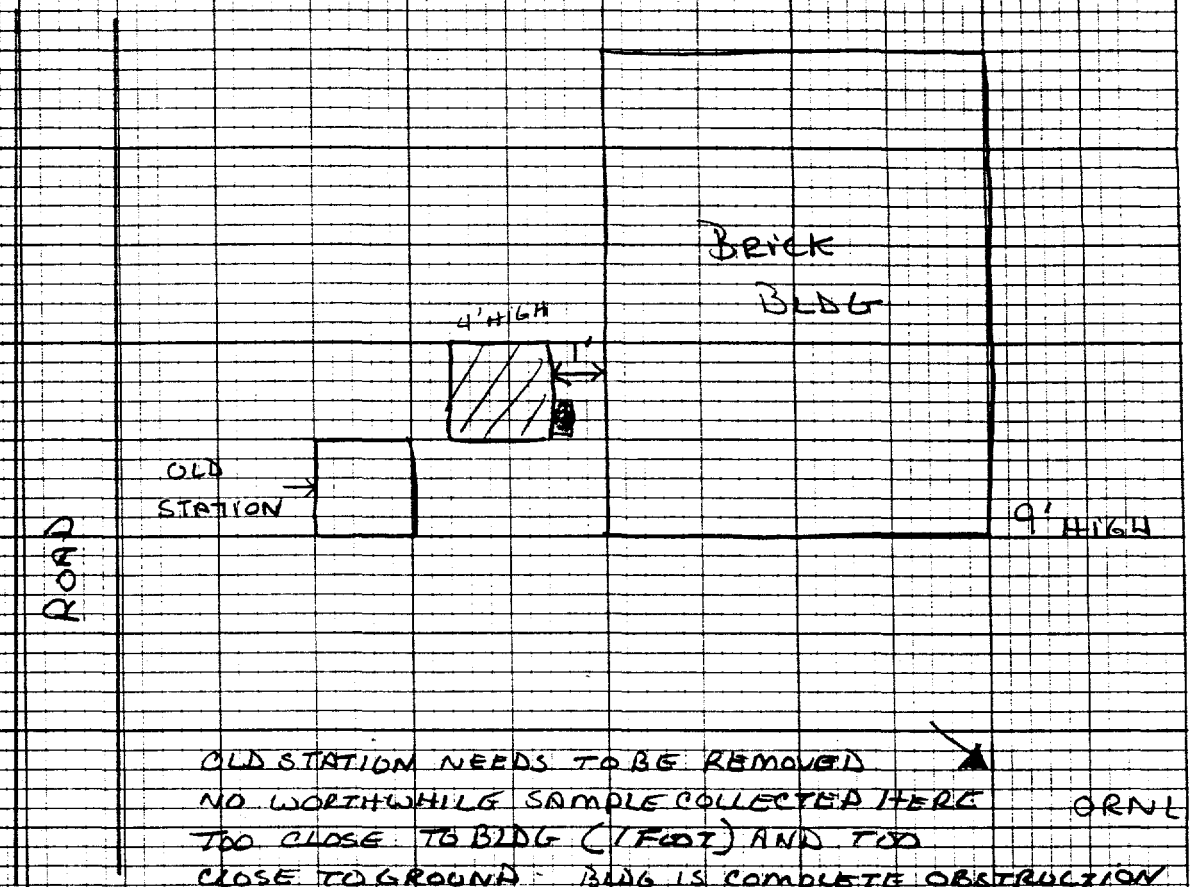
#22 DOSAR

OLD STATION NEEDS TO BE REMOVED
NO WORTHWHILE SAMPLE COLLECTED HERE
TOO CLOSE TO BLDG (1 FOOT) AND TOO
CLOSE TO GROUND. BLDG IS COMPLETE OBSTRUCTION
TO SAMPLE COLLECTION.

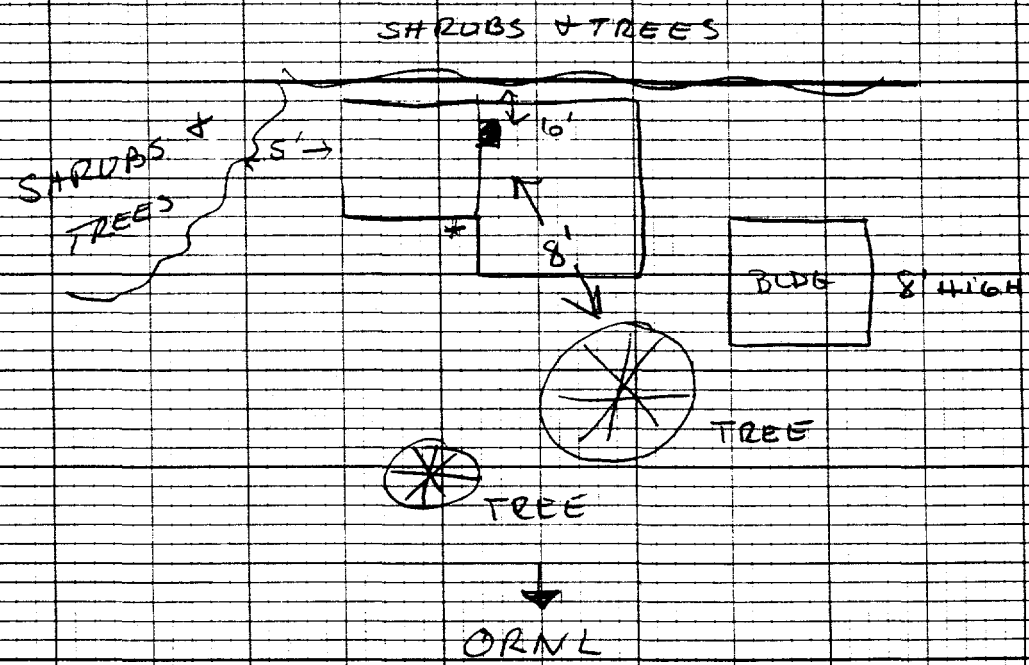
#44 EGC&R

SAMPLER LOCATED ON WRONG SIDE OF BLDG. SHOULD BE
WHERE (*) IS. TWO TREES NEED TO BE CUT.
FILTER SHOULD BE UPRIGHT.

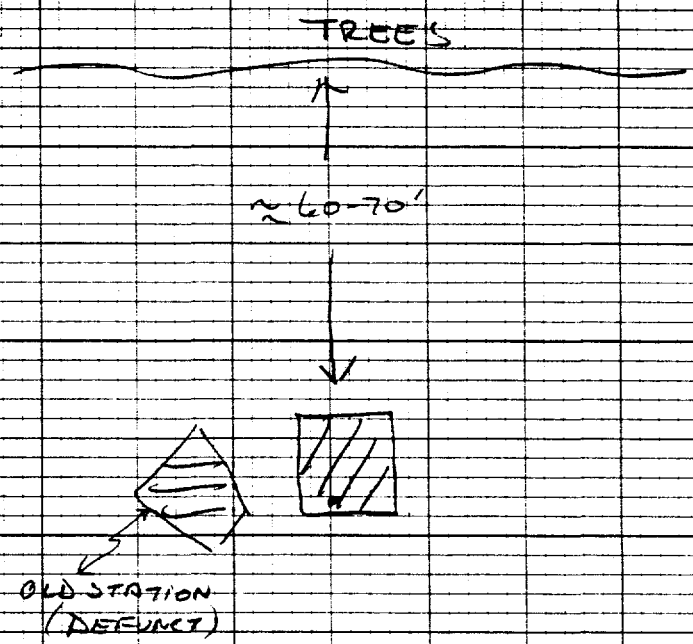
#23 WALKER BRANCH

TOO LOW TO THE GROUND
OLD STATION SHOULD BE REMOVED

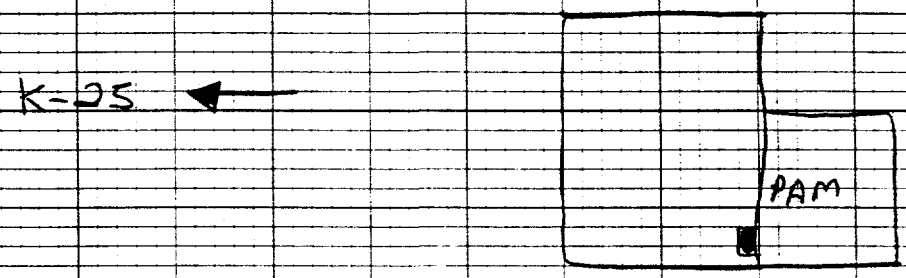
#43 K-25 COOLING TOWER / PERIMETER RD

LOCATED ON A CLEARED HILLSIDE

GOOD LOCATION

FILTER SHOULD BE UPRIGHT

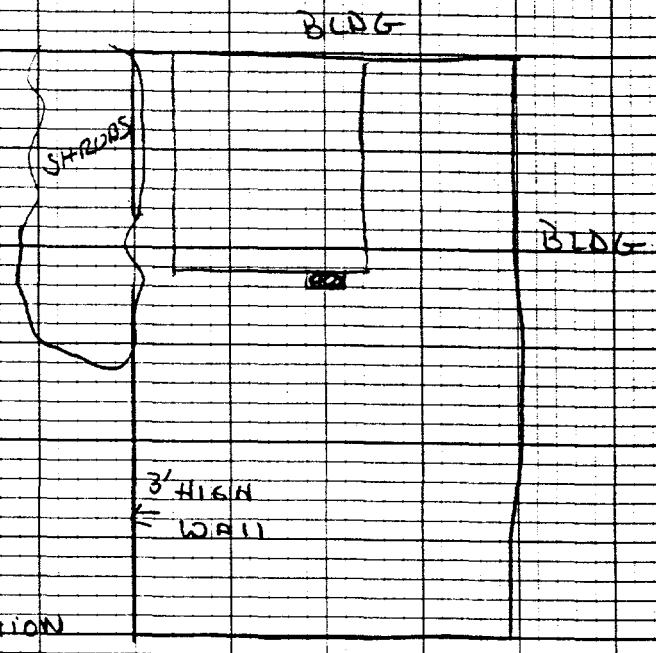
#41 DOE MUSEUM

LOCATED ON 2ND FLOOR PATIO

VERY POOR SAMPLE LOCATION

BLDG IS AN OBSTRUCTION, TREE IS AN OBSTRUCTION.

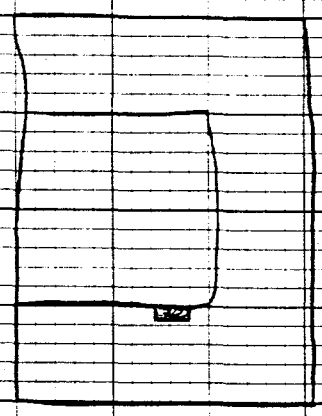
#46 Scarborough AREA

GOOD AREA CLEARANCE.

SAMPLER LOCATED IN A COMPLETELY FENCED IN ENCLOSURE WITH WOOD SLATS. DO NOT BELIEVE IT WOULD PASS EPA. RESTRAINT DUE TO RESIDENTS IN AREA.
(WOOD SLATS)

Filter should be upright.

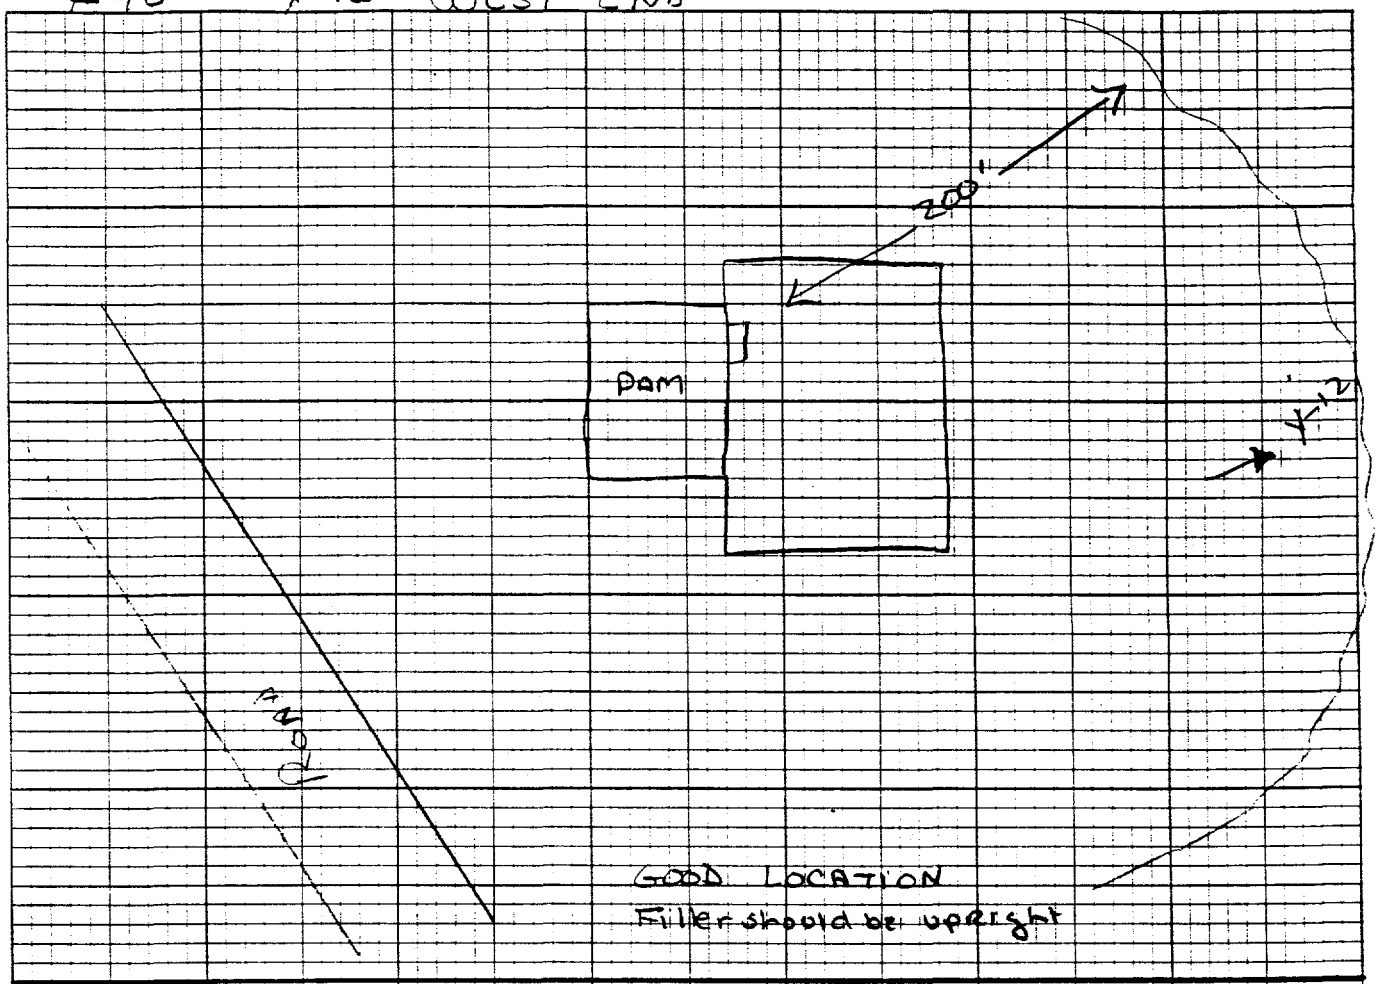
#40 Y-12 WEST END

GOOD LOCATION
Filter should be upright

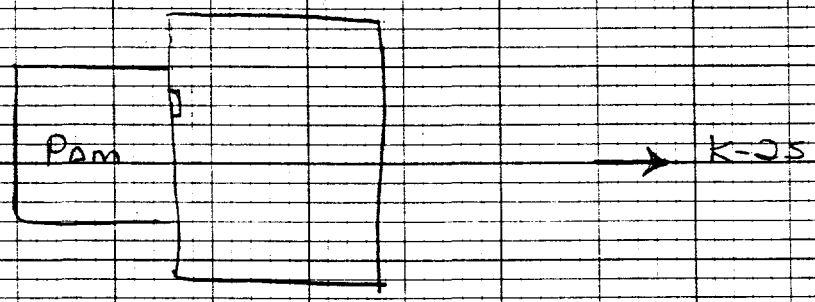
#42 K-25 BLAIR ROAD

GOOD LOCATION

NO OBSTRUCTIONS

Filter should be upright.
