INTRA-LABORATORY CORRESPONDENCE

OAK RIDGE NATIONAL LABORATORY

Subject: SUMMARY OF DIFFICULTIES WITH TRENCH NO. 6

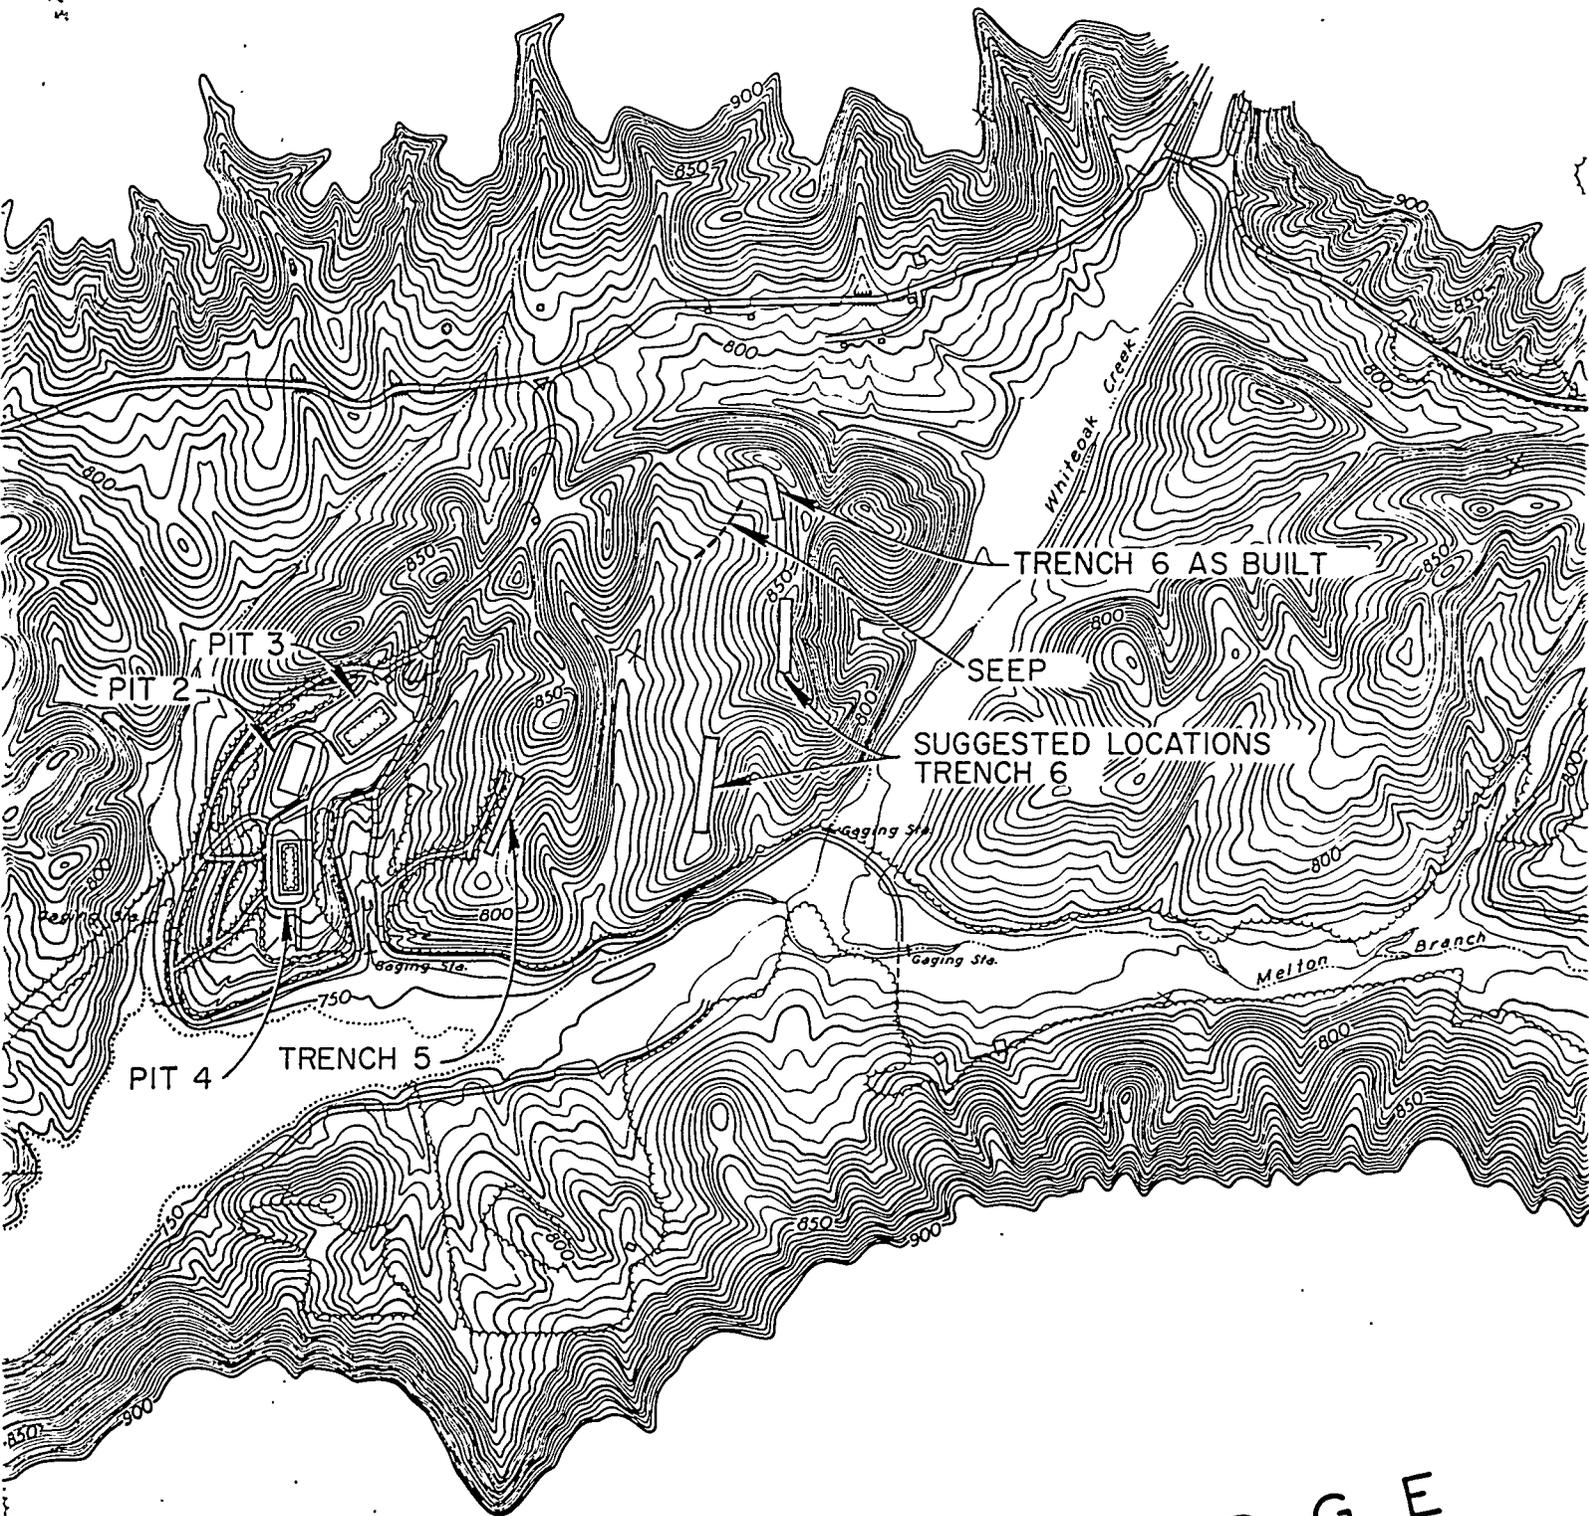
UNCLASSIFIED
ORNL-LR-DWG 63051

A part of the Melton Valley topographic map is shown in Fig. 41. The present operating pits are shown at I. The next ridge to the east, II, will probably be the site of the next disposal pit. The topography here is favorable, and four test wells have shown a depth to the water table of about 40 ft. Still farther east, ridge III is also topographically suitable, although the steep eastern slope may require that the pit be located 50 or 100 ft west of the ridge crest. East of White Oak Creek there are several suitable ridges, although test wells and a study of ground-water conditions would be required before any decision could be made. East of the area shown in Fig. 41 the topography is less favorable and the pits would have to be smaller and more scattered. Present understanding of the problem suggests that the best area for waste disposal pits extends about 2 miles east of the present operating pits. The results of studies to date suggest that this area should be reserved for future disposal of intermediate-level liquid waste.

Seepage pits for the disposal of intermediate-level liquid waste have been in operation in Melton Valley for several years, and despite their many defects, will have a limited but valuable function for some time to come. Study of the present pits has suggested valid criteria for the selection of future sites.
